LERNER DEPARTMENT STORE
3105-09 Wilson Boulevard
Arlington
Virginia

HABS VA-1282
VA-1282

WRITTEN HISTORICAL AND DESCRIPTIVE DATA

LERNER DEPARTMENT STORE

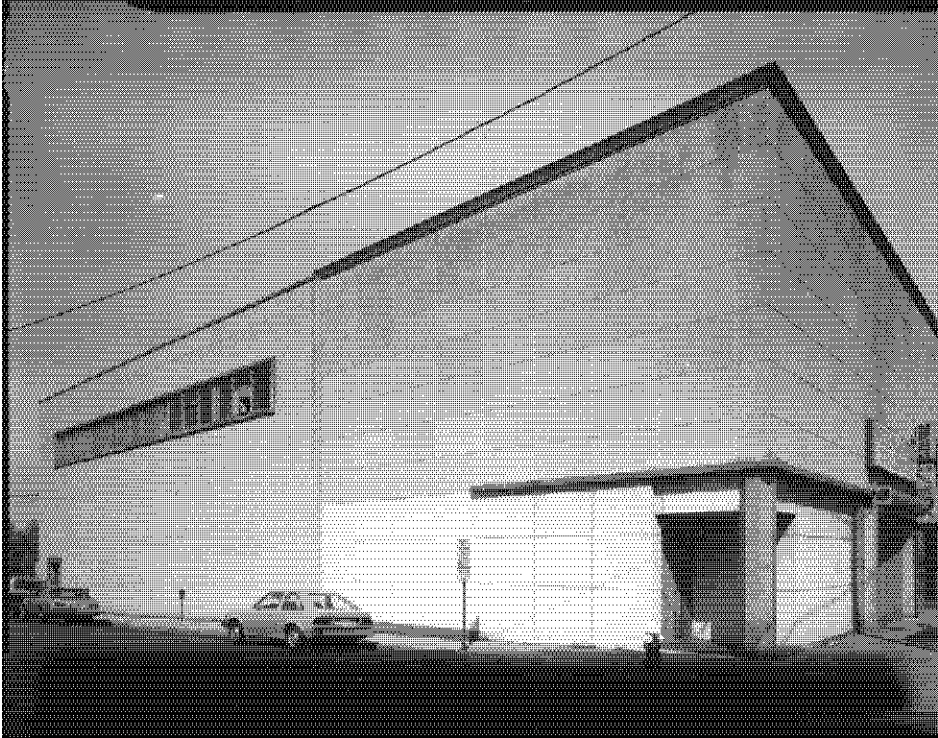
Documentation of the Hahn Shoe Building (HABS No. VA-1281) and the Lerner Department Store was done to mitigate the impending loss of several historic Arlington County buildings, including those in the 3100 block of Wilson Boulevard. Below is an image taken by John C. Schwartz, photographer, in spring 1990.
